SAFETY INVESTIGATION REPORT

**HELLENIC AIR FORCE F-16D BLK 50
S/N 93-1084 341SQ/111CW**

**ALBACETE AFB (ESP), ALBACETE
26 JANUARY 2015**

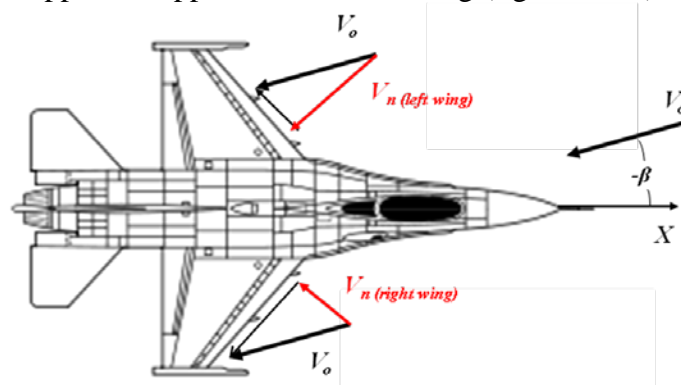
The movement of the MA's nose to the right during the sideslip produced an aerodynamic right wing down rolling moment. The recorded roll was approximately 7° at the first second following WOW and increased dramatically to approximately 33° in the following second. The roll continued increasing bank until the MA impacted the ground. The main causes of the rolling moment were as follows:

-The F-16 is equipped with an aft-swept wing. In all aft-swept wing A/C, during sideslip, the upwind wing toward the velocity vector (left in MA) produces more lift than the downwind wing as the normal vector of the velocity (the one perpendicular to the leading edge of each wing – V_n (left wind)) is increasing. The "spanwise" vector of the velocity produces no lift. The opposite happens to the other wing (right in MA).

Rolling moment because of sideslip with an aft-swept wing

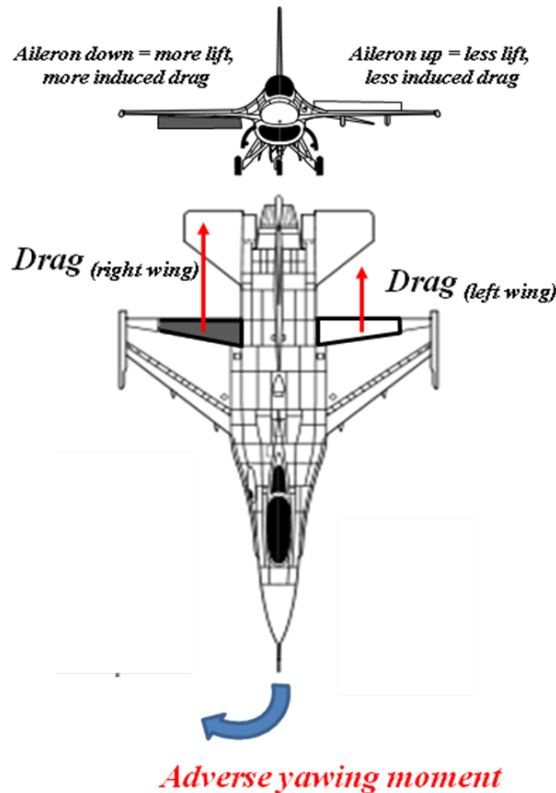
Although the right roll moment was decreased approximately at 2.5 sec after WOW (from approximately 22 degrees/second to 6.6 degrees/second), left control stick inputs were insufficient to cease the right roll. Due to the MA lack of desired response, PIC increased the left control stick command. At 2.6 seconds following WOW (32:30.88), the maximum value (which is the maximum available) left roll stick input was recorded (-22 pounds)⁵. This left roll control stick input, without ARI activation (no automatic rudder to offset adverse sideslip due to roll surface deflections), enhanced the nose right sideslip due to increased drag generation from the wing. The result was additional MA's yaw to the right (adverse yaw). Additive to the sideslip factors were the asymmetric store on right wing and the 9 knot wind from 330° (60° right from the nose).

Adverse yawing moment due to aileron deflection
